# Patterns 7

December 1990

Published by Buro Happold Consulting Engineers

<b>A case study in appraisal and reuse</b>	Ted Happold and John Froud	2
<b>New headquarters for Imagination, Staffordshire House, London</b>	Mike Cook, Ian Liddell and Tony McLaughlin	5
<b>Repair and refurbishment at the Assembly Rooms, Bath</b>	Tony McLaughlin and Terry Ealey	11
<b>Marples Wharf – a transformation of the Bayer Building, Bath</b>	Richard Harris	14
<b>Phased refurbishment of York House, London</b>	Howard Bays	17
<b>Kingsmead revitalised – redeveloped neighbourhood housing in Bath</b>	Geoff Werran and Tony Williamson	19
<b>From car repair to designer wear in Brompton Road, London</b>	Peter Brooke, Michael Dickson and Mick Green	24
<b>Control of ground water rise at the Souk Al Kuwait and Souk Al Kabir buildings, Kuwait</b>	Terry Ealey and Peter Beresford	27
<b>A full repairing lease</b>	Bill Biggs	31

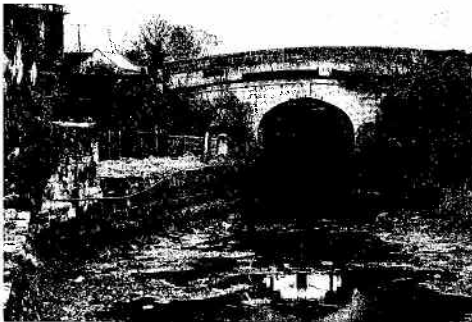
Fig 1.6 Bed of drained Kennet and Avon canal

In complete contrast, over-zealous removal of silt can also generate problems, and the canal should only be drained to perform such an operation if it has been ascertained that wall failure will not occur. (Fig 1.6) The canal bed profile must have also been considered and care must be taken not to perforate the puddle clay lining of the bed.

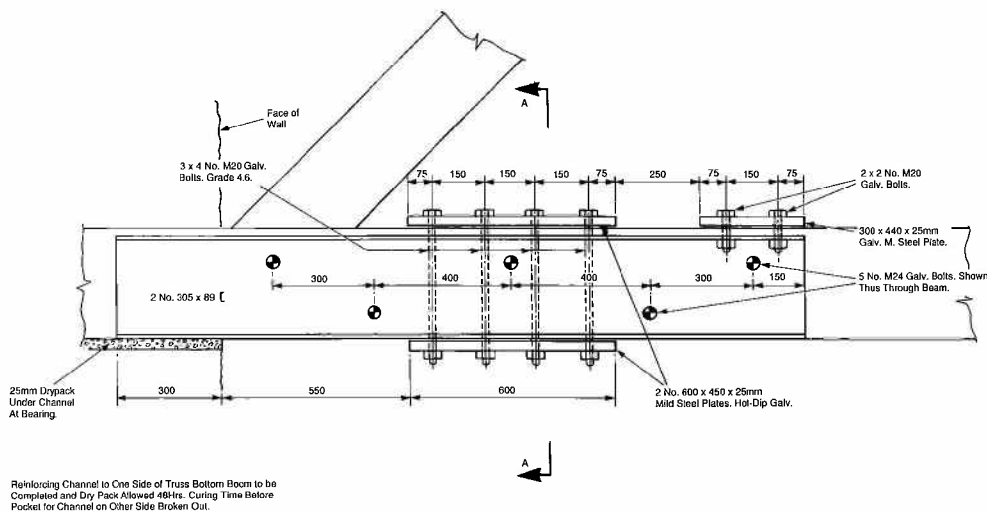
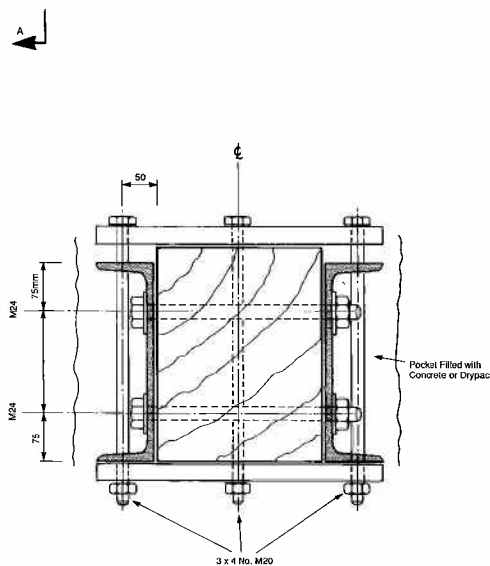
Fig 3.4 (a) Repair to decayed roof timber  
(b) Section through truss repair

Attention has however, been focused again on the building, highlighting further refurbishment needs. On the night of 13 October 1987 a section of plaster fell from the ceiling of the Ballroom without any apparent cause. Through good fortune no one was hurt. The City Council acted quickly, closing the building to the public, and immediately appointing a team of consultants with an initial brief to investigate and report on the failure. As part of this initial brief the consultants were also asked to consider the implication of any repair work.

The ceiling support structure comprised both straight and curved ceiling joists fixed to the underside of the horizontal tie members of the large section timber roof trusses. There were no apparent defects in the structure which could have caused the failure of the ceiling. The chandelier support structure comprised structural steelwork sections supported directly on the top of the horizontal tie members of the timber roof trusses. Again there were no apparent defects.

Reinforcing Channel to One Side of Truss Bottom Beam to be Completed and Dry Pack Allowed 48hrs. Cutting Time Before Pocket for Channel on Other Side Broken Out.

Survey revealed no signs of major structural weakness and so no reason to instigate a full structural appraisal of the building. However some minor repairs to timber connections were recommended. (Fig 3.4 a, b) Further recommendations suggested that checks be conducted at regular intervals on the roof timber and that walkways be installed in some of the roofways to provide safe access for maintenance staff.

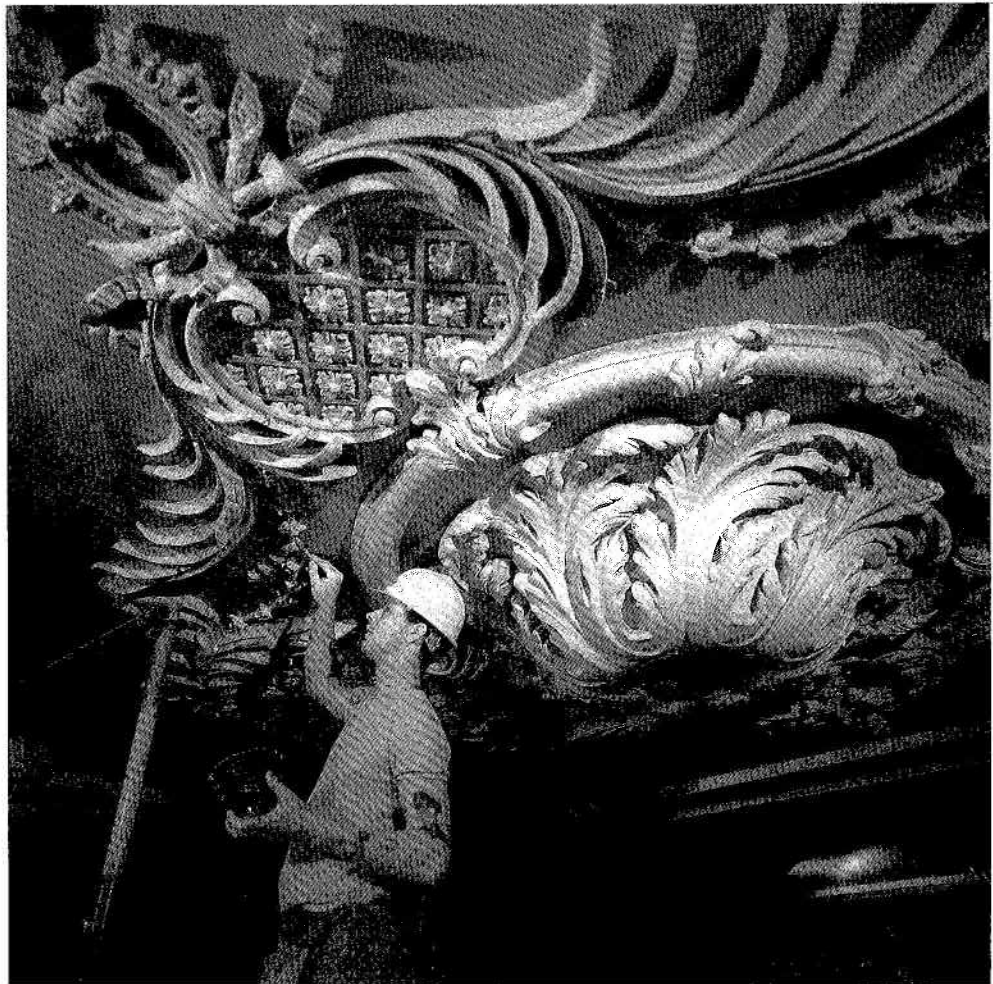
Fig 3.6 Fallen plasterwork of ceiling rose

Work was completed at the end of September 1990, three months ahead of the original programme – a credit to all who were involved. But what of the failure of the plasterwork which started it all? Research by the architects and their advisers has indicated that failure was due to a mismatch of plaster layers. Simply stated, browning plaster had been used over metal lathing plaster and the two layers had separated. The rescued ceiling rose (Fig 3.6) has now been successfully reinstated, once more resplendent in this beautiful building.

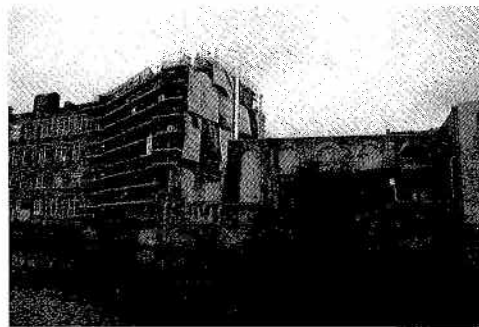
Fig 4.2 (a) A deteriorated riverside elevation  
(b) Interior before redevelopment

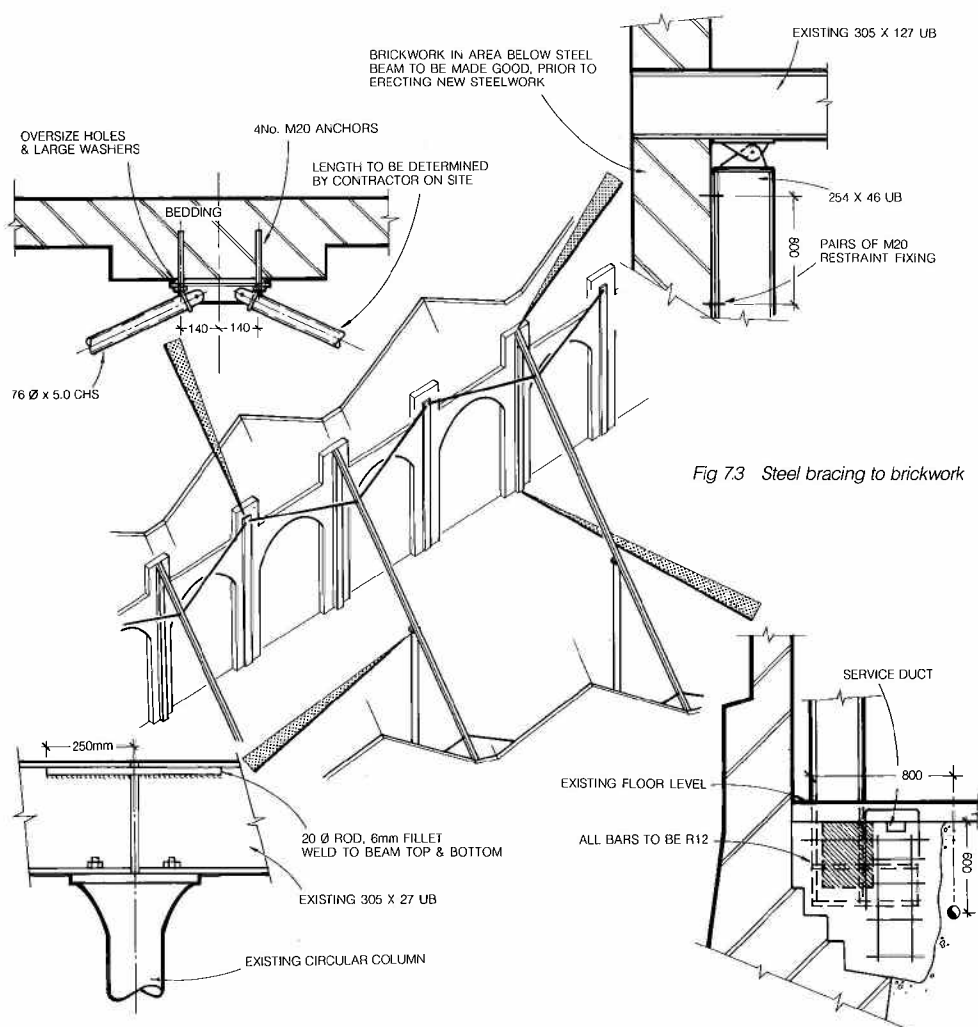
Fig 7.3 Steel bracing to brickwork

The removal of the first floor and the 25mm tie rods would have resulted in the wall overlooking the Circle Line becoming unstable. The proposals therefore required very careful co-ordination of temporary and permanent work to meet the stringent requirements imposed by London Transport for work over their lines. Internal cantilever steel columns were provided to stabilise the roof plane, prop the walls and as a primary support for the scaffold cage over the underground line. All work on the erection and removal of the scaffold and safety nets was carried out at night, which then allowed daytime access for strengthening and repointing of the wall. Internally, new strengthening steelwork was designed to be simple and elegant and in accord with the existing steelwork and new building services. (Fig 7.3)

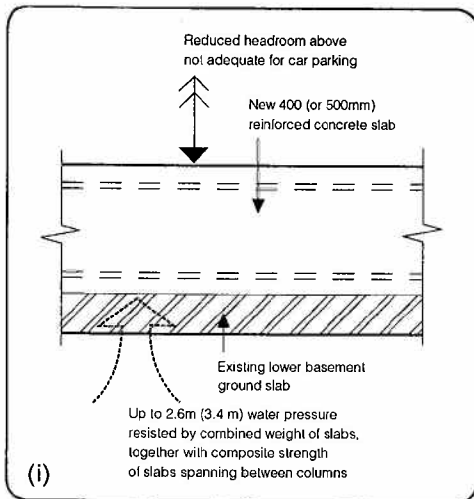
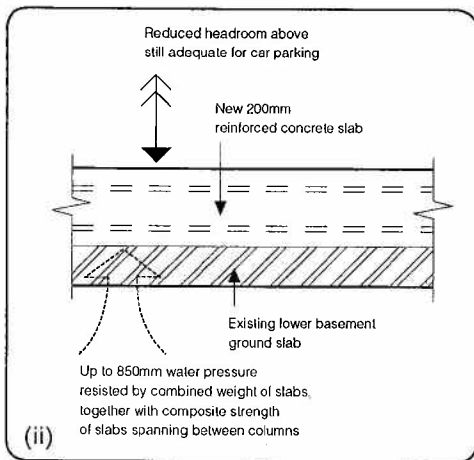
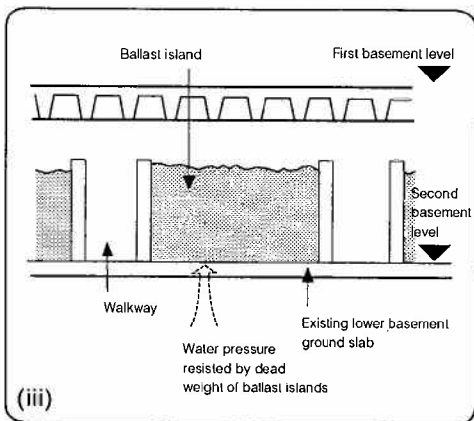
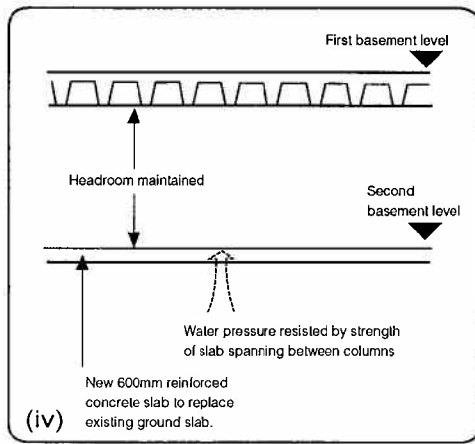
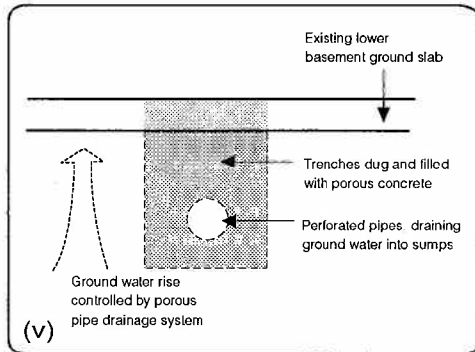
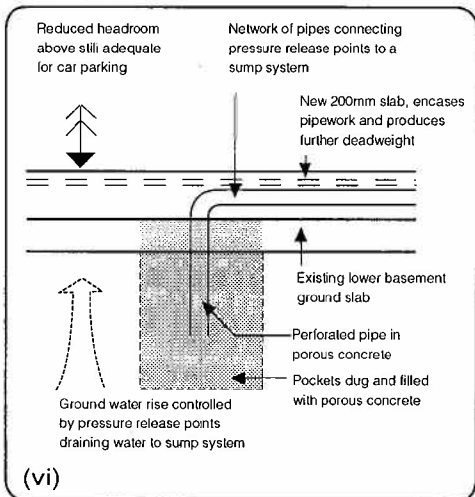
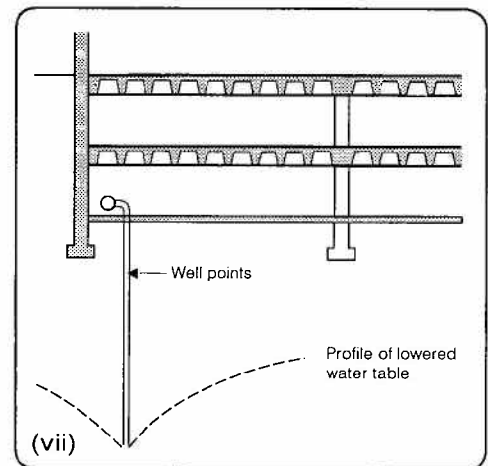
A report considering the effect of further rises in water table, the range of factors contributing to its rise over recent years, and the action which could be taken to counter the effects of further rises was then

Fig 8.3 Solutions considered in control of ground water rise

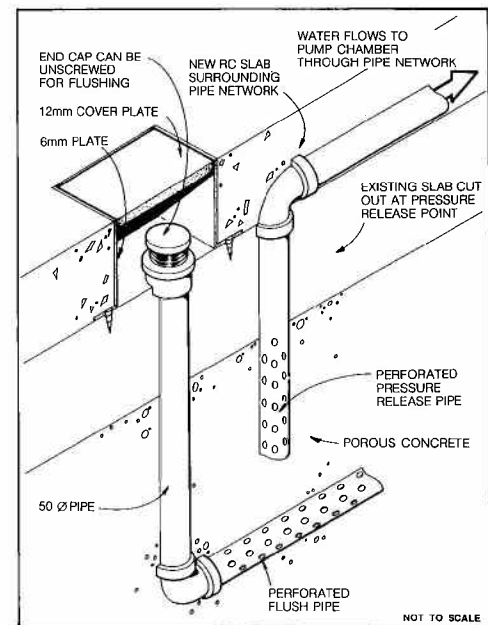
Fig 8.4 Isometric of pressure release drainage pipe

Porous concrete was mixed in small tumble mixers on the spot and the existing slab was made good around the protruding plastic pipes. A network of pipes was then laid and tested (Fig 8.5), and covered in reinforcement in bays, prior to concreting during
