Patterns 6

'Those Ills We Have'	Bill Biggs	2
Horsham Town Centre Redevelopment	Rod Macdonald	4
Warehouse and Office Development for Schwarzkopf UK.	John Morrison	8
Infrastructure and Highway Design for Emersons Green Science Research Park, Avon	Vincent Grant and John Froud	13
An Atrium at Buckingham Gate, Westminster	Mick Green, Peter Moseley and Ben Kaser	19
Lighting the High-Tech Office	Paul Ruffles	24
Restoration Behind the Listed Facade – Colonnades, Bath	Richard Harris and Simon Wright	26

Editorial Foreword

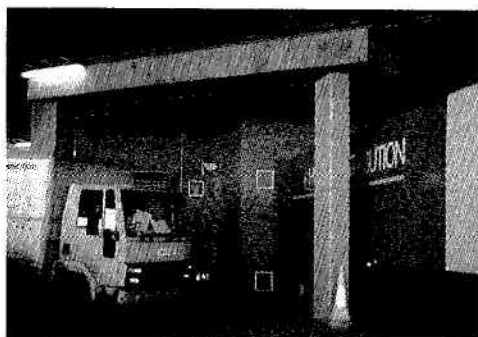
Fig 2.4 Relocated column of multi-storey car park

Demonstration indicated that the resited Sainsbury delivery bays would only operate satisfactorily if one of the main multistorey car park columns was relocated. This was a ground to first floor column under a 5 storey car park with 12.5m beam spans. The new foundation and column was built in in-situ concrete, the relevant section of first floor was cut out and a new in-situ concrete beam formed to sit on the new column and collar the existing one (Fig 2.4). Prestressing was used to ensure the shear connection between the new and the old, and when the concrete was significantly cured the old column was removed. The whole operation was successfully carried out with only minor restriction to parking facilities.

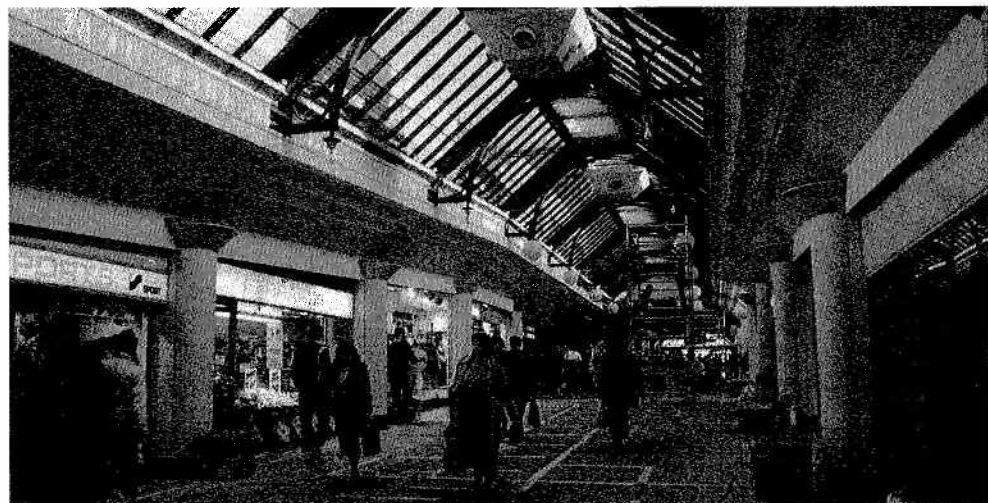
Fig 2.10 New glazed roof of refurbished Swan Walk shopping mall

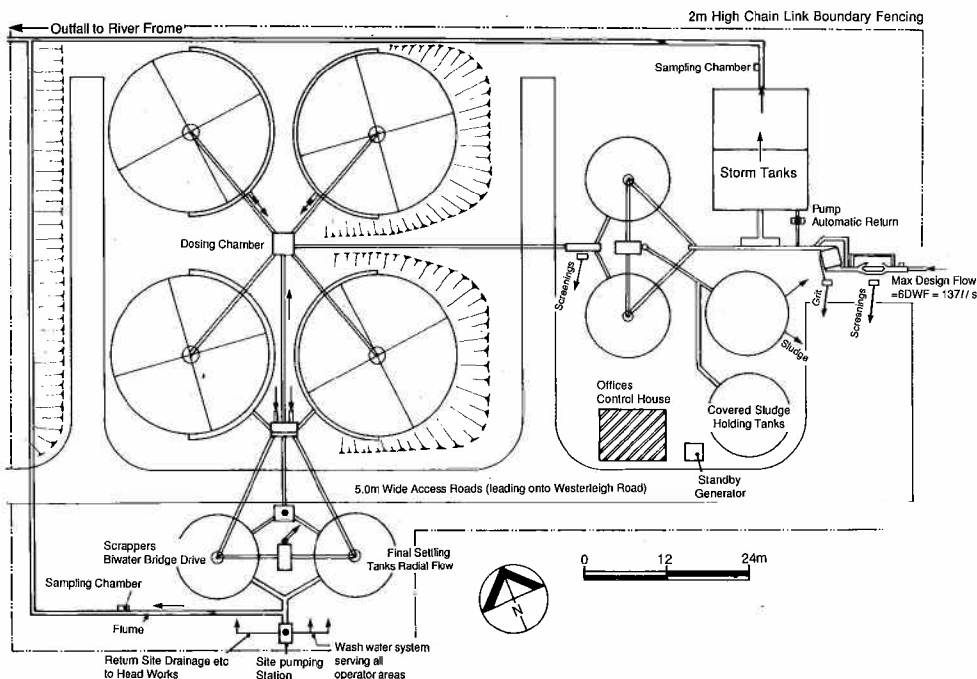
Fig 4.10 Filter plant layout for on-site sewage treatment works

As an alternative, proposals are being developed to provide an on-site treatment works to treat effluent to the appropriate standard, and discharge it westwards to the River Frome itself (Fig 4.10). The standards and operating equipment in the works are being established in discussion with Wessex Water and the National Rivers Authority (NRA) to achieve an effluent discharge satisfying the requirements necessary to obtain consents under the terms of the Land Drainage and Control of Pollution Acts.

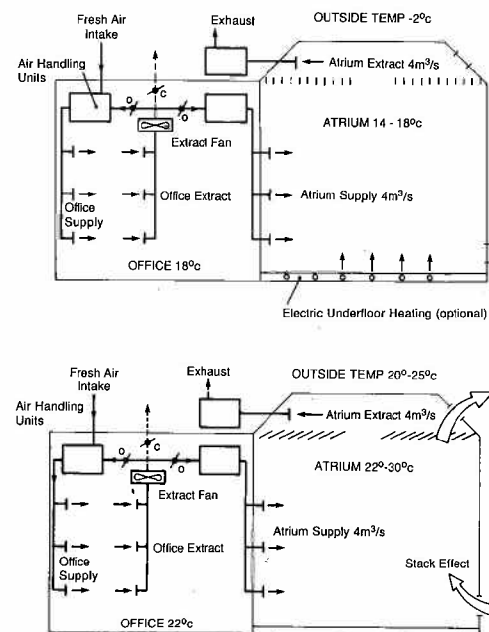
Fig 5.4a,b Temperature control in winter and summer - early scheme

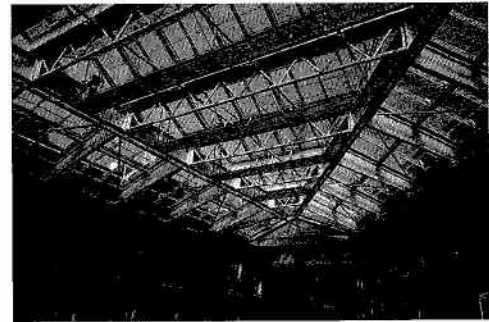
Fig 5.12 Cleaning gantry high in atrium enclosure.

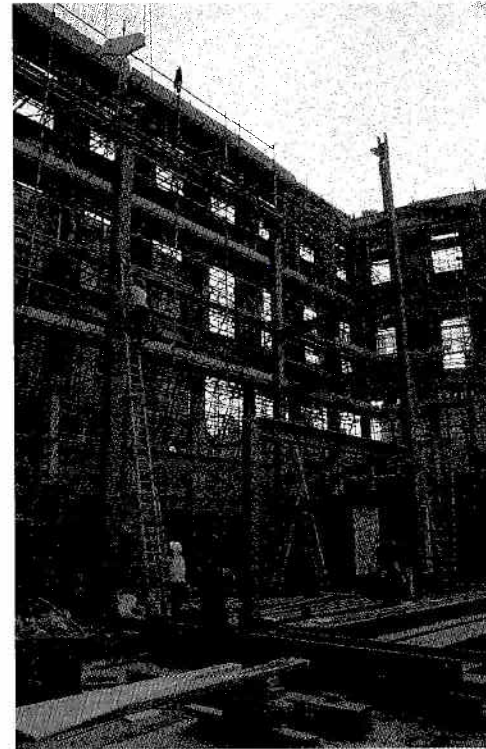
Fig 7.4 Shored facade standing alone above excavated basement

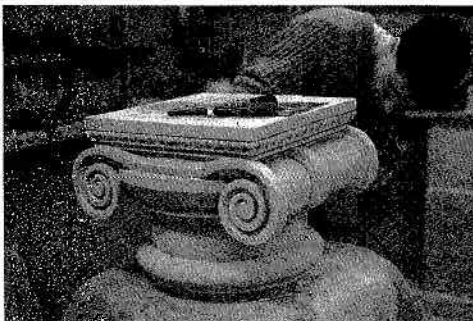
Fig 7.11 Stonework repair in stonemason's workshop

Bath stone is a very soft material. It is very consistent and easily worked to provide very intricate details, but it does deteriorate over the years. There has thus been continuous work for stonemasons in Bath for the past 250 years, both in building new buildings and in restoring and repairing old ones. There is
