Patterns 11

August 1993

Published by Buro Happold Consulting Engineers

A journey in Saudi Arabia	Edmund Happold	2
The Kasr Al Hokm District Redevelopment, Riyadh	Padraic Kelly, Terry Ealey and Rodger Webster	8
The Grand Mosque, Riyadh - Jamea Al Imam Turki bin Abdulla	Terry Ealey and Padraic Kelly	13
Half Moon Bay - A resort complex in eastern Saudi Arabia	Padraic Kelly and Graham Pontin	18
Quba Mosque, Medina	Michael Dickson and Richard Harris	21
Strengthening of a 26-storey apartment tower - The Sultan Tower, Cairo	Terry Ealey	24
Damage assessment in Kuwait	Terry Ealey, John Froud and Richard Harris	26
Pearls of Kuwait - Environmental assessment as part of the design process	Judith Teasdale	32

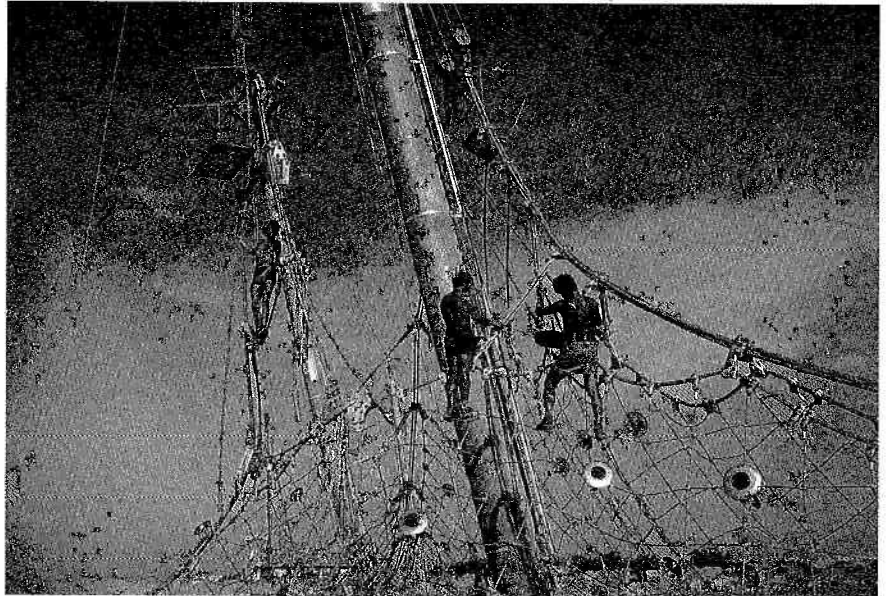
Fig 1.13 Cable net erection - Jeddah 1979

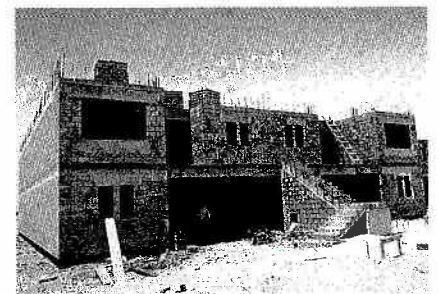
Fig 4.3 Structures following halt on work in December 1989

work. When works finally came to a halt, all of the housing units had been structurally completed (Fig 4.3) while most of the infrastructure, including a deep sewer, was still to be constructed. Individual villas had final-fix M&E and internal joinery but no external doors or windows, a particularly significant problem given the frequent spring sand storms and the prevailing high summer humidity.

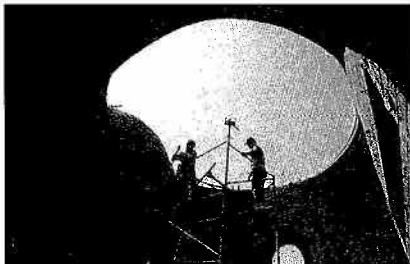
Fig 5.8 Typical construction without forms of larger dome

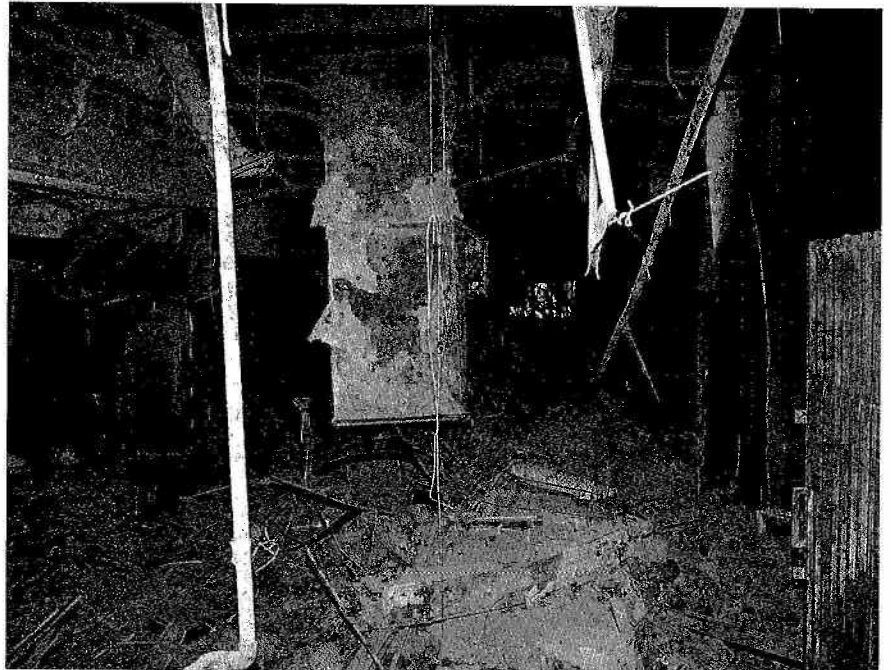
Fig 7.4 Fire damage inside Souk Al Kabir

windows shattered and many had been set ablaze, resulting in widespread fire and smoke damage (Figs 7.2 & 7.3) Eighty-seven separate fires were identified during the appraisal, completely destroying building services and finishes in most areas. At the areas of intense fire (Fig 7.4), severe damage

had occurred to all elements of the building structure, with floor slabs showing signs of partial failure in several locations. The eleven storey Ministry of Electricity and Water (MEW) headquarters office building had suffered damage from shelling and small arms fire during the early days of the Iraqi

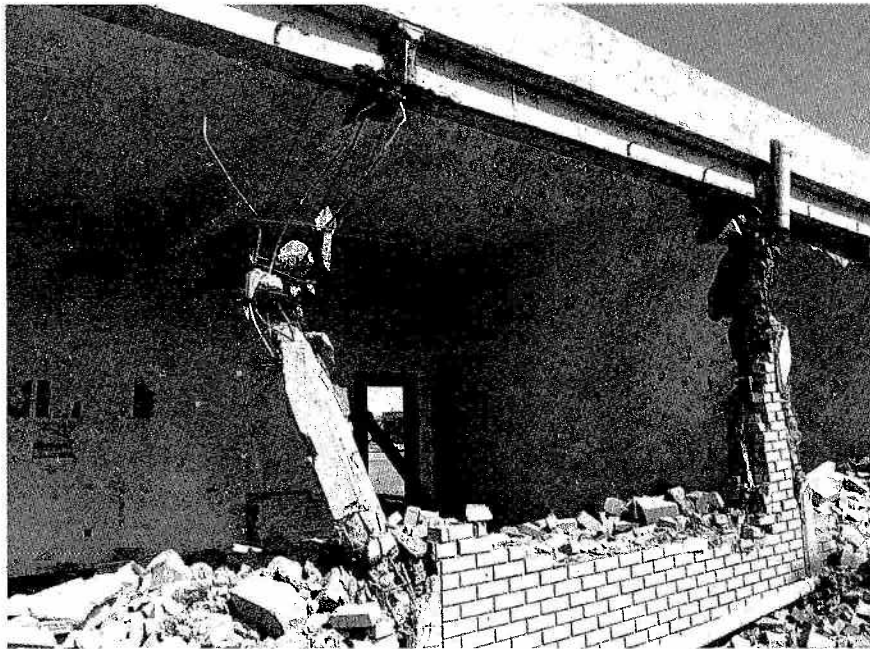
Fig 7.9 Destruction of walls and columns by tracked vehicle - MOD complex

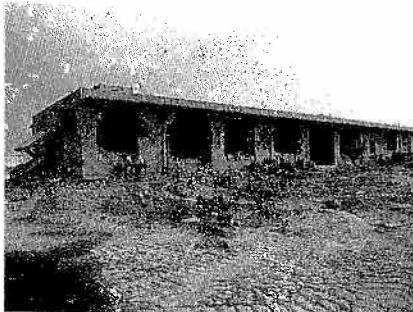
Fig 7.10 Destruction by tracked vehicle in MOD complex

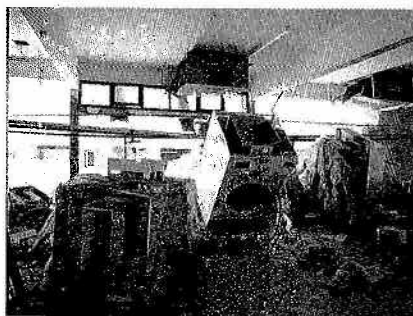
Fig 7.12 Vandalism to laundry equipment - MOD complex

At about the same time, Buro Happold was also appointed in association with local consultant, OHA, by the Kuwait Ministry of Defence to carry out damage assessment on a large military project which had been under construction at the time of the invasion. The site occupied an area of approximately 40 hectares containing over 80 structures. These included ammunition stores, warehouses, dormitories and workshops, constructed in concrete frame with a cladding of sand lime bricks. The project had been nearing completion at the time of the invasion and was used by Iraqi troops during the occupation. The principal damage to the structures had been caused by tracked vehicles driven into building facades (Figs 7.9 & 7.10), although in some instances explosives had been used to effect partial or complete collapse (Fig 7.11). Extensive looting of materials and equipment had taken place and buildings had been badly vandalised (Fig 7.12).

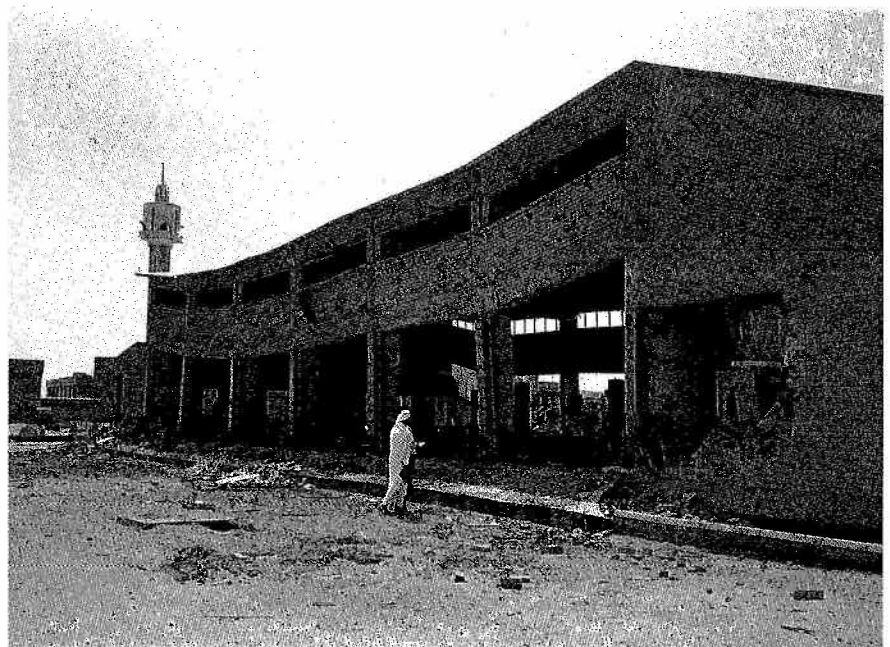
Fig 7.11 Explosive damage at base of columns in maintenance building of MOD complex

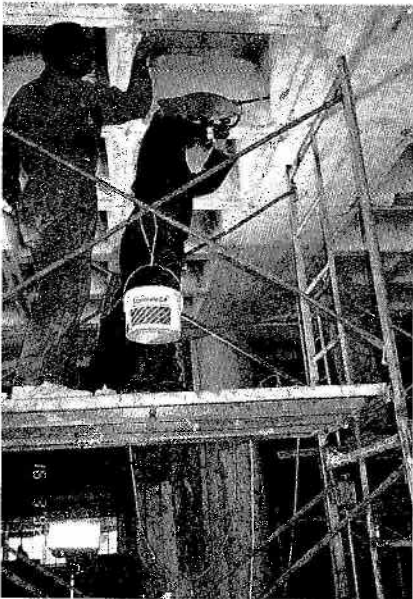
Fig 7.18 Resin injection of cracks in fire damaged concrete.

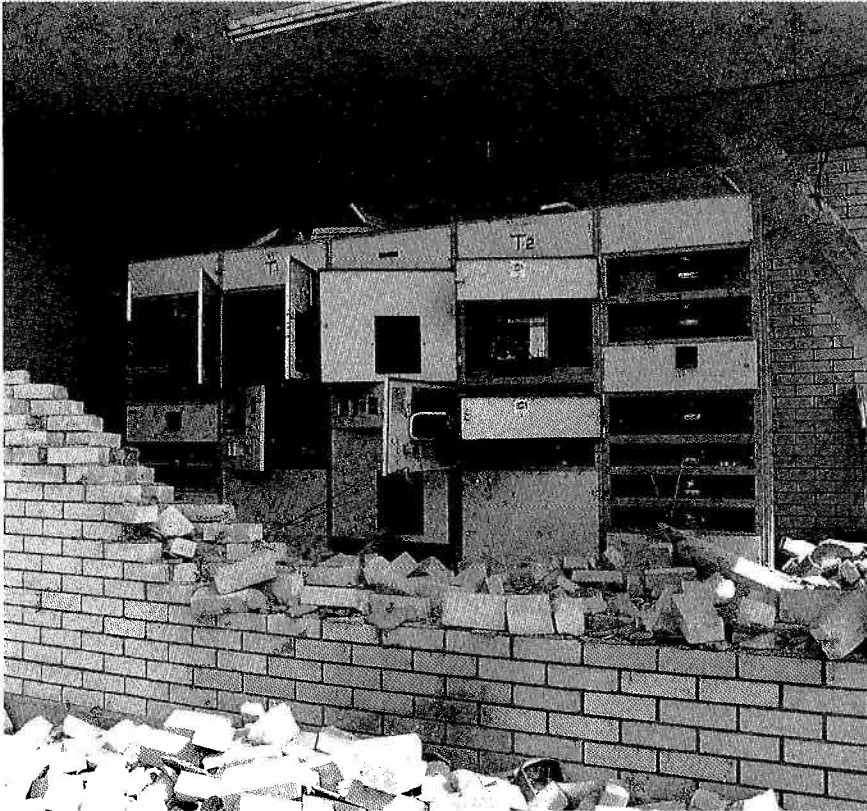
Fig 7.21 Destruction of walls and structure of substation, and of switchgear
