# Patterns 7

December 1990

Published by Buro Happold Consulting Engineers

<b>A case study in appraisal and reuse</b>	Ted Happold and John Froud	2
<b>New headquarters for Imagination, Staffordshire House, London</b>	Mike Cook, Ian Liddell and Tony McLaughlin	5
<b>Repair and refurbishment at the Assembly Rooms, Bath</b>	Tony McLaughlin and Terry Ealey	11
<b>Marples Wharf – a transformation of the Bayer Building, Bath</b>	Richard Harris	14
<b>Phased refurbishment of York House, London</b>	Howard Bays	17
<b>Kingsmead revitalised – redeveloped neighbourhood housing in Bath</b>	Geoff Werran and Tony Williamson	19
<b>From car repair to designer wear in Brompton Road, London</b>	Peter Brooke, Michael Dickson and Mick Green	24
<b>Control of ground water rise at the Souk Al Kuwait and Souk Al Kabir buildings, Kuwait</b>	Terry Ealey and Peter Beresford	27
<b>A full repairing lease</b>	Bill Biggs	31

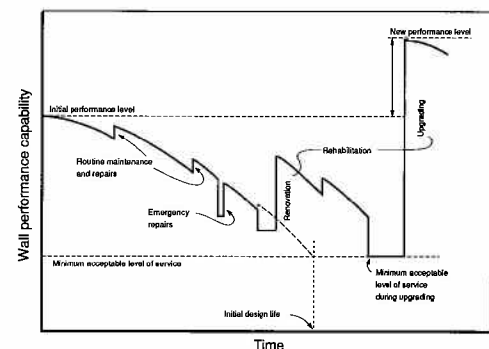
With frequently changing ownership it was inevitable that maintenance was carried out in a piecemeal fashion, a problem common to many waterways. If a small section of wall collapsed within a larger length, a repair would be carried out and all would be well – a trial and error maintenance operation, minimising the amount of work to be done at any one time, but requiring a continuous maintenance operation. (Fig 1.3) This should not suggest that our

Fig 1.3 Concepts of canal maintenance and rehabilitation

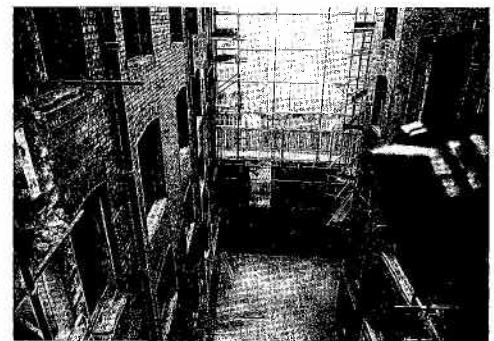
The existing building, a rather drab, Edwardian Ministry property, presented an imposing five storey brick facade in a slight crescent off Store Street. (Fig 2.2) Six to eight metres behind, and linked by a brick-built toilet block, stood a second four storey brick block, reconstructed after the Second World War. The unused and extremely bleak brick faced gap between the buildings absorbed most of the light penetrating the space. (Fig 2.3)

Fig 2.3 Original drab space between parallel buildings of Staffordshire House

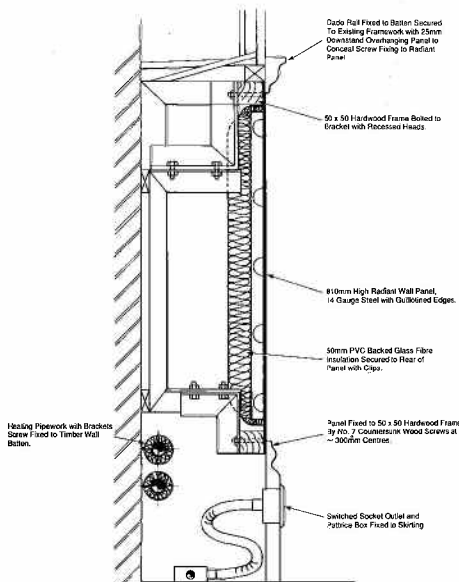
Fig 3.5 Detail of radiant panel heaters in the ballroom

Consequently, work was carried out on the mechanical systems, replacing the heating system pipework and emitters throughout, with the exception of one part of the building. The recently installed boilers were retained and overhauled, but all boiler room pumping, pipework and controls were renewed. The Ballroom and Tea Room are heated by radiant panels concealed within the wall between skirting and dado. (Fig 3.5) The Octagon is heated by an underfloor system whilst the Card Room and Little Octagon are heated by fan convectors concealed behind ornate wooden enclosures. Each of the major rooms is provided with its own zone control system and the Ballroom is further divided into four individual control zones. Corridors are heated by radiators. Concealed pipework which runs in the ceiling space, is heavy grade steel with welded joints and the system is valved in such a way that runs of pipework can be isolated should a leak occur.

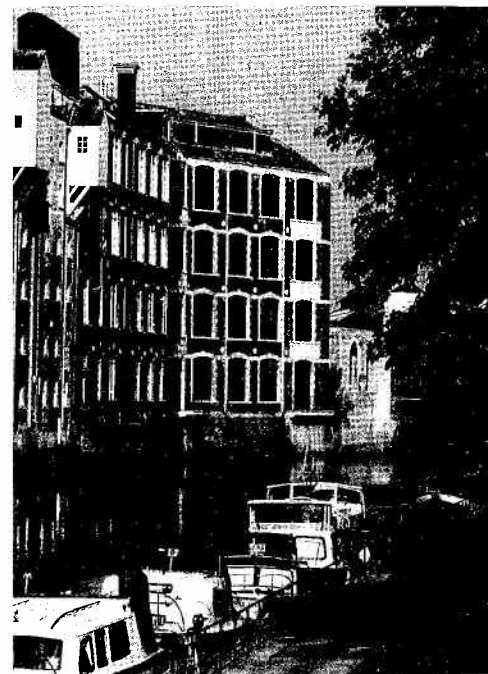
Fig 4.8 Refurbished river elevation

Work carried out on the riverside wall, to be retained as a feature screening the car park, was a close representation of the complete refurbishment of the building. As originally constructed, it was entirely adequate as an external load-bearing wall of a building. The client however wished to change its use to that of a free standing screen to the car parking area where horizontal wind rather than vertical roof weight becomes the dominant loading. Survey and analysis of the existing state of the wall revealed unbonded piers and large pieces of timber built into the brickwork, all limiting the wall's ability to resist horizontal loading. A scheme was produced to show how, with strengthening provided by the careful insertion of reinforced concrete beams into the brickwork and new ties between existing unbonded buttresses and the wall, the refurbished wall could perform its required new function. As the strengthening work was carried out, deterioration and built-in items which had not been evident in the original survey were revealed and details had to be adjusted to suit. The finished wall, (Fig 4.8) showing little evidence of the successful strengthening work, and in close parallel with the Bayer Building itself,

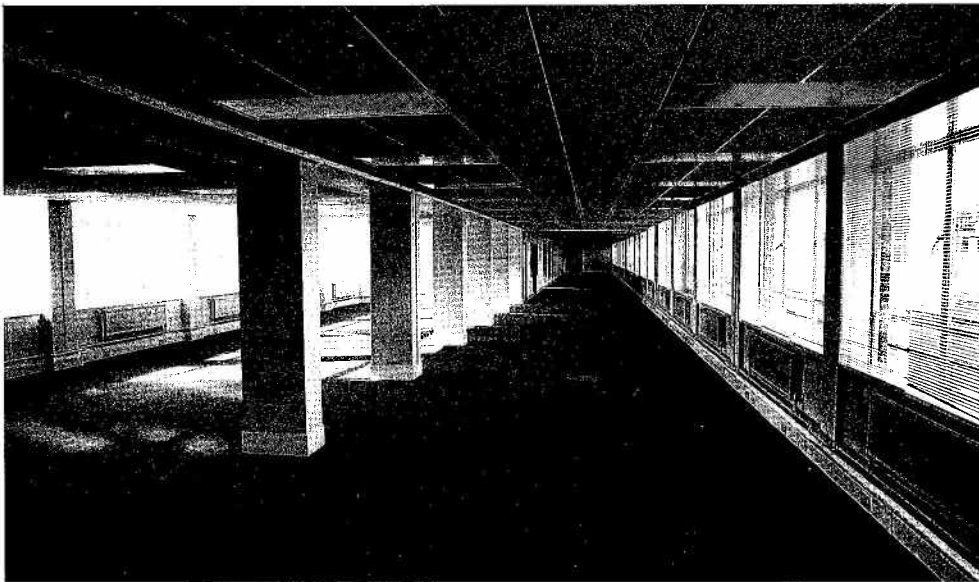
Fig 5.3 Refurbished third floor level

requirements. Ceilings, lighting and finishes were completely removed on each floor, together with all existing perimeter cast iron column radiators which were deemed too bulky and aesthetically unpleasing. New lighting, with an illuminances level of 500 lux, was provided and thermostatically controlled panel radiators, three compartment perimeter trunking and new power distribution boards were installed. Finally, new floor and wall finishes were applied. (Fig 5.3)

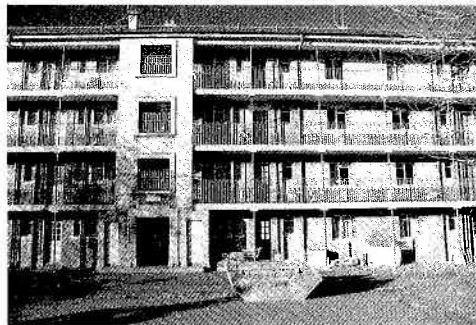
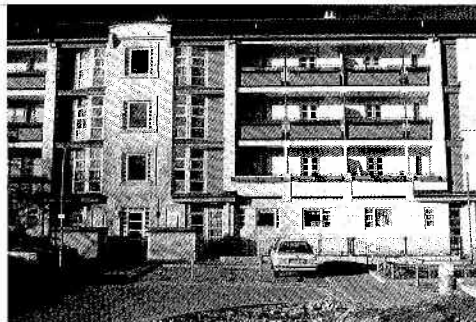
Fig 6.5 Elevation of Kingsmead East  
(a) Before refurbishment  
(b) After refurbishment

Work on Kingsmead East and West included the removal of the existing recessed external wall at ground floor level and the construction of a new external wall on the balcony line, thus enlarging the ground floor to include the balcony area. (Fig 6.5 a, b) This was extended above to form a masonry parapet to the now individual balconies at first floor level. In all cases, additional piles needed to be installed along the balcony line to carry the additional loads. This necessitated the removal of existing tie beams to the columns, and so the provision of temporary lateral restraint to the existing columns was yet another factor to be accommodated in the design. A new system of ground beams was then cast connecting the new piles to the existing piles and ground beams. The limited access, restricted headroom and proximity to both existing and temporary structure led to the choice of 450mm diameter, bored and cast-in-situ piles that could be installed by means of a simple tripod-mounted percussion rig.

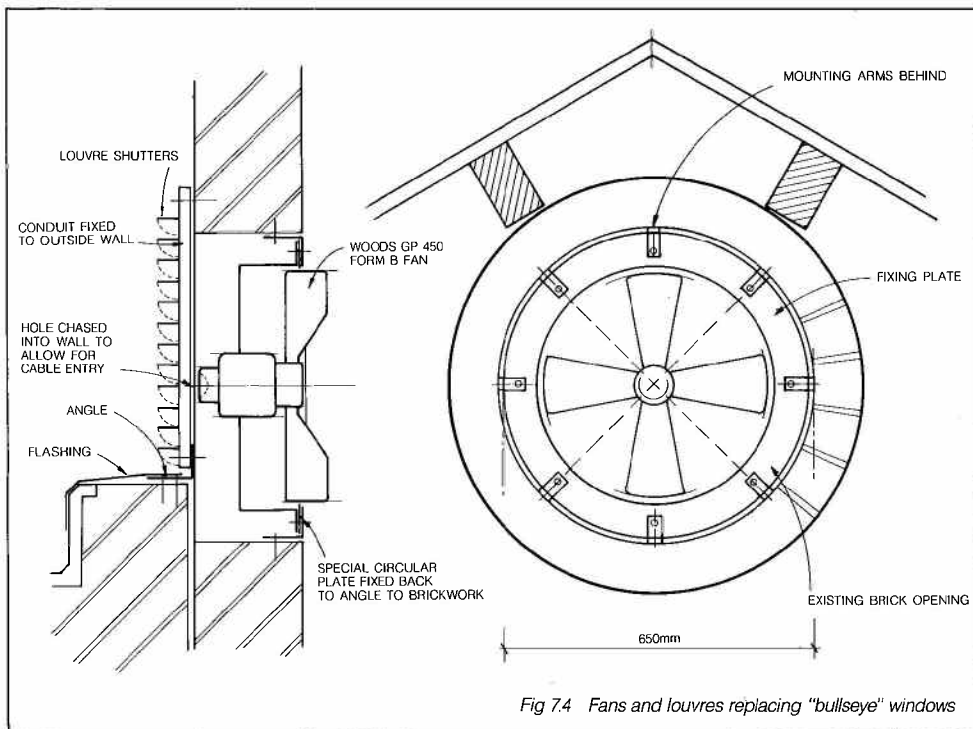
Fig 7.4 Fans and louvres replacing "bullseye" windows

With large areas of single glazed roof lights and windows and a poorly insulated structure, both substantial winter heating and summer ventilation were required. To achieve the architect's desire for 'an elegant warehouse' appearance for the building, services engineers designed a heating system utilising bare pipes and finned tube. Pipework anchors, supports and fixings were specially designed to give the desired appearance. Ventilation was provided by replacing high level 'bullseye' windows with propeller fans and individually designed and fabricated louvres. (Fig 7.4)
