Patterns 2

The Changing Role of the Consultant Engineer in the UK	Ted Happold	2
An Extension to Worcester College, Oxford	Rod Macdonald	4
Fire Engineering	Mick Green	8
Refurbishment at the Royal College of Art, London	Peter Brooke, Richard Harris & Din Patel	13
Butter Process Plant for Anchor Foods, Swindon	John Morrison & Peter Buckthorp	18
Wellsite Engineering	Vincent Grant	21
Community Buildings under Westway, London	Peter Cunningham	23

Editor Robbie McElhinney
Technical Editor Michael Dickson

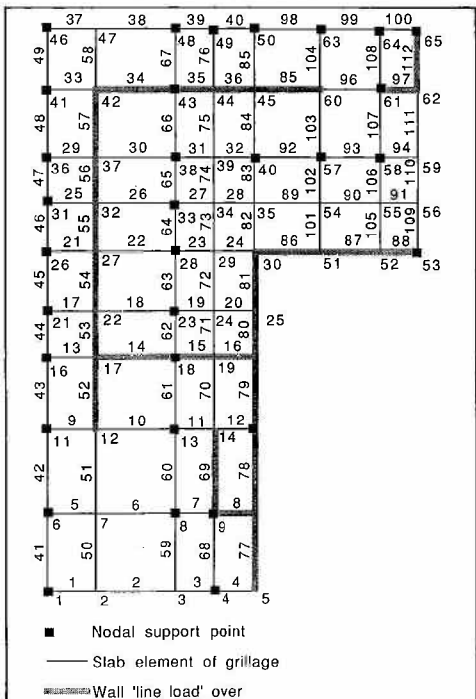
Fig 2.7 Elastic analysis of 'grillage' analytical model

using the Minitec grillage program (Fig 2.7), and care was taken to keep deflections and, in particular, curvatures of these slabs within acceptable limits. A grade (iv) cement : lime : sand mortar was used to allow the maximum possible tolerance to movement in the blockwork. Horizontal reinforcement was used at points of stress concentration.

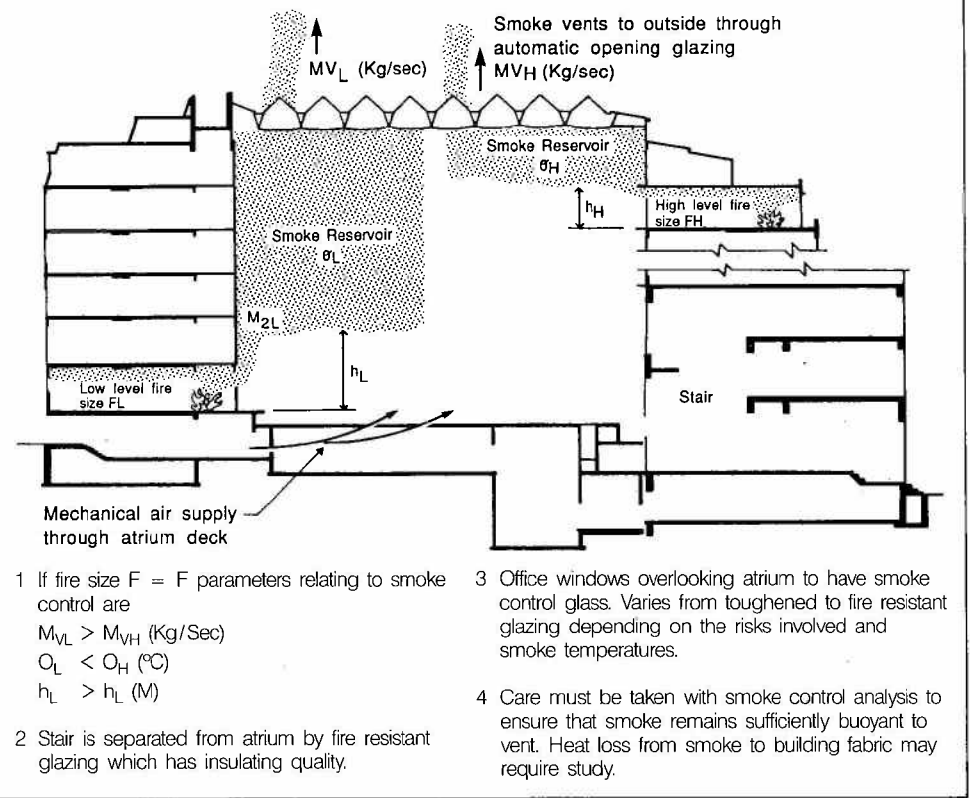
Fig 3.5 Section through atrium, Buckingham Gate – Fire engineering design

- 1 If fire size $F = F$ parameters relating to smoke control are
 $M_{VL} > M_{VH}$ (Kg/Sec)
 $O_L < O_H$ (°C)
 $h_L > h_H$ (M)
- 2 Stair is separated from atrium by fire resistant glazing which has insulating quality.
- 3 Office windows overlooking atrium to have smoke control glass. Varies from toughened to fire resistant glazing depending on the risks involved and smoke temperatures.
- 4 Care must be taken with smoke control analysis to ensure that smoke remains sufficiently buoyant to vent. Heat loss from smoke to building fabric may require study.

A further solution with the option of using the atrium base as an office was then studied. It was not feasible to incorporate a mechanical system to extract smoke floor by floor due to the restricted existing headroom restraints. The area of windows overlooking the atrium had been reduced which had made the use of half-hour non-insulated fire-resistant glass economically viable. The exception was the existing listed stairway which was isolated using one-hour insulated glass to ensure safe means of escape. The resultant smoke control scheme was nominal and was primarily for secondary smoke clearance purposes. This final solution was selected and is currently under construction (Fig 3.5).

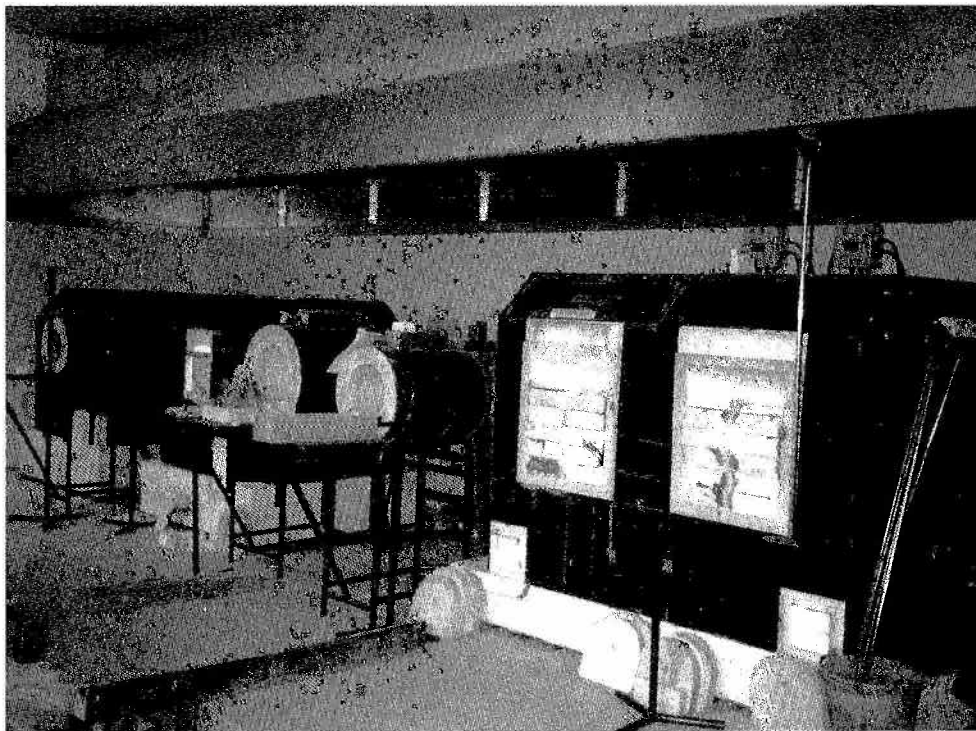
Fig 4.8 Glass furnace room – Darwin Workshop

glass furnaces within the School of Glass and Ceramics at 1st floor level. The existing system did not perform as predicted and extracted only half the volume of air anticipated. This led to complaints from the users that it was too hot in the room (Fig 4.8). The old extract ductwork, insulated with asbestos, had been sealed by the College a few years earlier, and incorporated no test or access holes whatsoever, even at fire damper positions. The package of works necessary on this system included asbestos removal, provision of access facilities, replacement of flexible connections and the fitting of a replacement motor and pulleys to increase the speed of the fan. Following the successful uprating of the fan, recommendations were made identifying ways in which the working environment in the kiln room could be further improved. The users opted to implement the main proposal involving the use of insulated screens to prevent the radiant heat from open kilns, firing at 1000°C, escaping into the working area (Fig 4.9a,b,c).

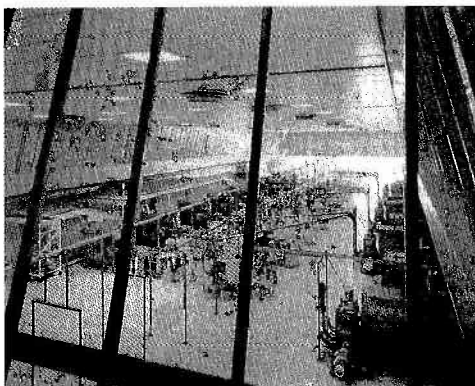
Fig 5.5 Main hall seen from 1st floor visitors' gallery

Another interesting feature of the process plant is the visitors viewing gallery (Fig 5.5) at 1st floor which permits visitors to look down through glass screens to see butter blending and packing in the main hall. The gallery screen is an inclined glass wall divided by inclined mullions which also support the cantilever from the roof structure above. The deflection limits of this complete system under snow, wind and live loads had to be carefully studied to ensure that there was no excess deflection which could distort and crack the glazed screen. The structural form was initially designed as a two dimensional frame with the corners checked as a three dimensional structure.

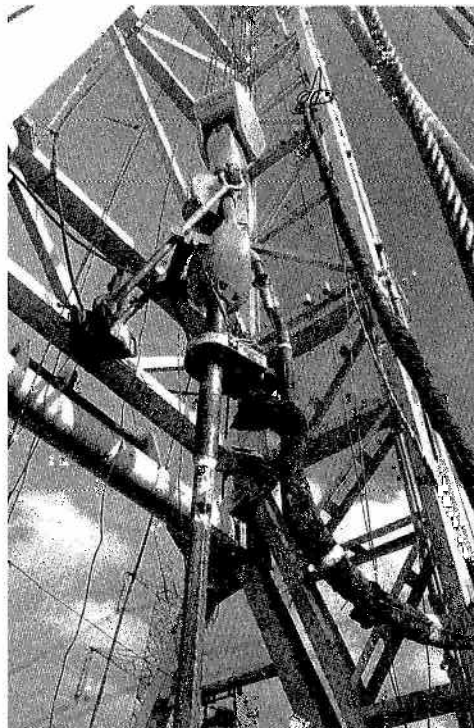
Fig 6.2 Drilling rig used during exploration phase

decision involves the extension of the original wellsite with the drilling of a production well, and the probable construction of further production wellsites in the locality (Fig 6.2). A gathering and distribution station comprising a tank farm, purification plant, administration facilities and loading facilities will also be required.

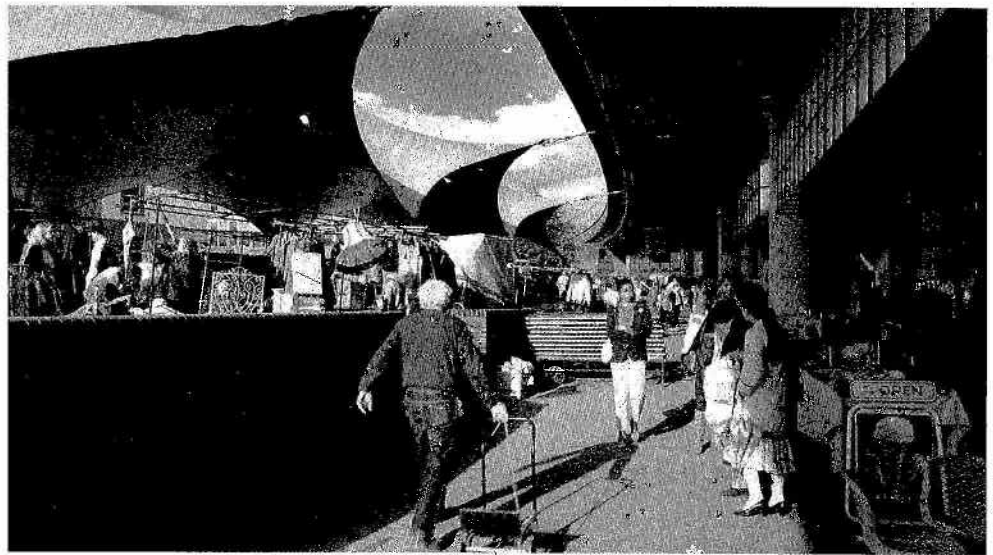
Fig 7.2 Market canopy located adjacent to Westway structure

All new structures were independent of the motorway structure but as close as possible to it to maximise the usable space (Fig 7.2). Foundations were generally pad footings on the firm London clay, many being adjacent to existing pile caps. However, where ground conditions were bad due to the existence of large amounts of fill or basements and footings of old houses, then reinforced concrete rafts were used. Foundations also had to take account of motorway drainage pipes which contain extremely high water pressure jets during cleaning of the highway above.
